A discussion on a common cause of Stationary Battery related UPS failures

Written by: Mike Jump
Vice President, Operations
Data Power Monitoring Corporation

SUDDEN IMPEDANCE/RESISTANCE RISE (SIRR)

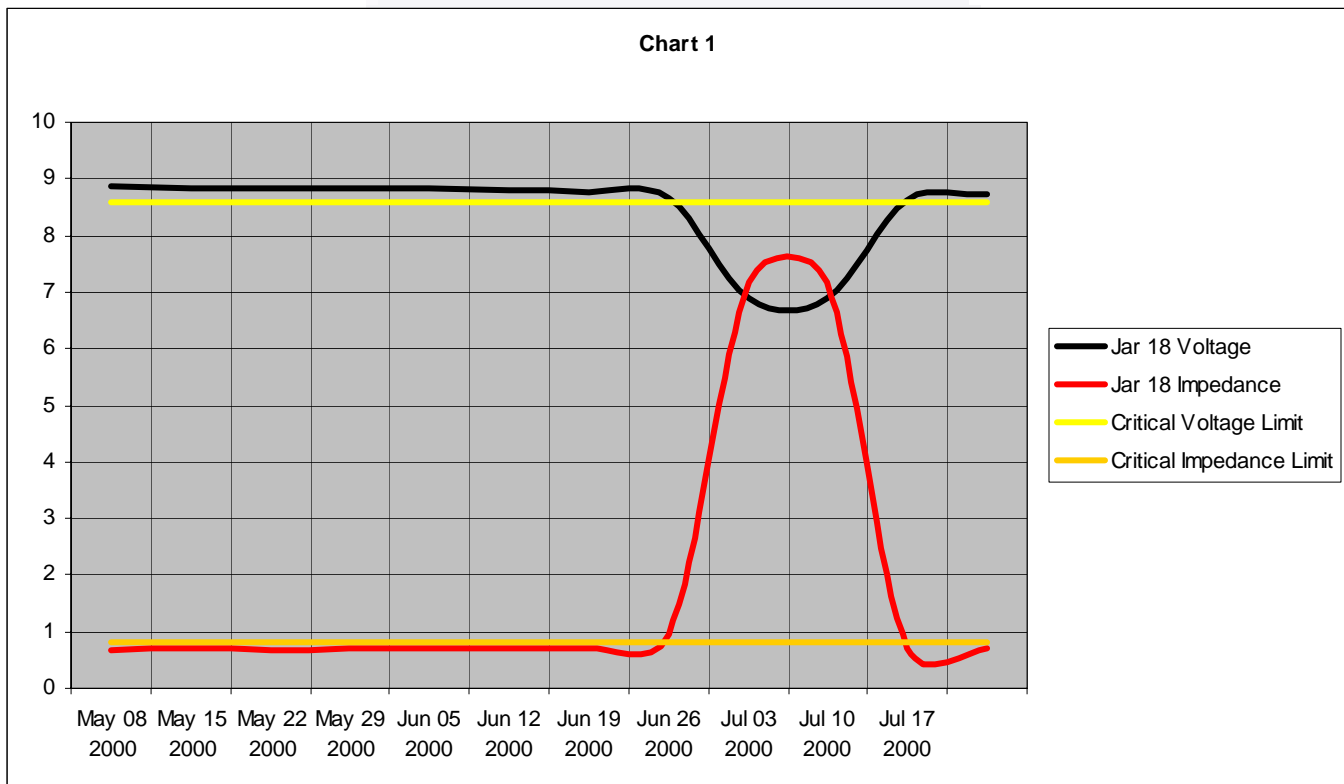
Chart 1 shows a flooded battery with an initial impedance/resistance of $0.67\text{m}\Omega$. The maintenance threshold on this battery would be $0.77\text{m}\Omega$ and the replacement threshold would be $0.8\text{m}\Omega$. This battery was installed in December 1998 and trended normally until late May 22, 2000. A “Spot Test” associated with quarterly maintenance on June 19, 2000 would have shown this battery to be within acceptable standards, the voltage level may have called for a recommendation to equalize the string. **SIRR** is clearly indicated from June 26 to July 10 and the battery was replaced by July 17. The **Voltage Trend** demonstrates a corresponding fall in voltage sometimes associated with the rise in impedance/resistance.

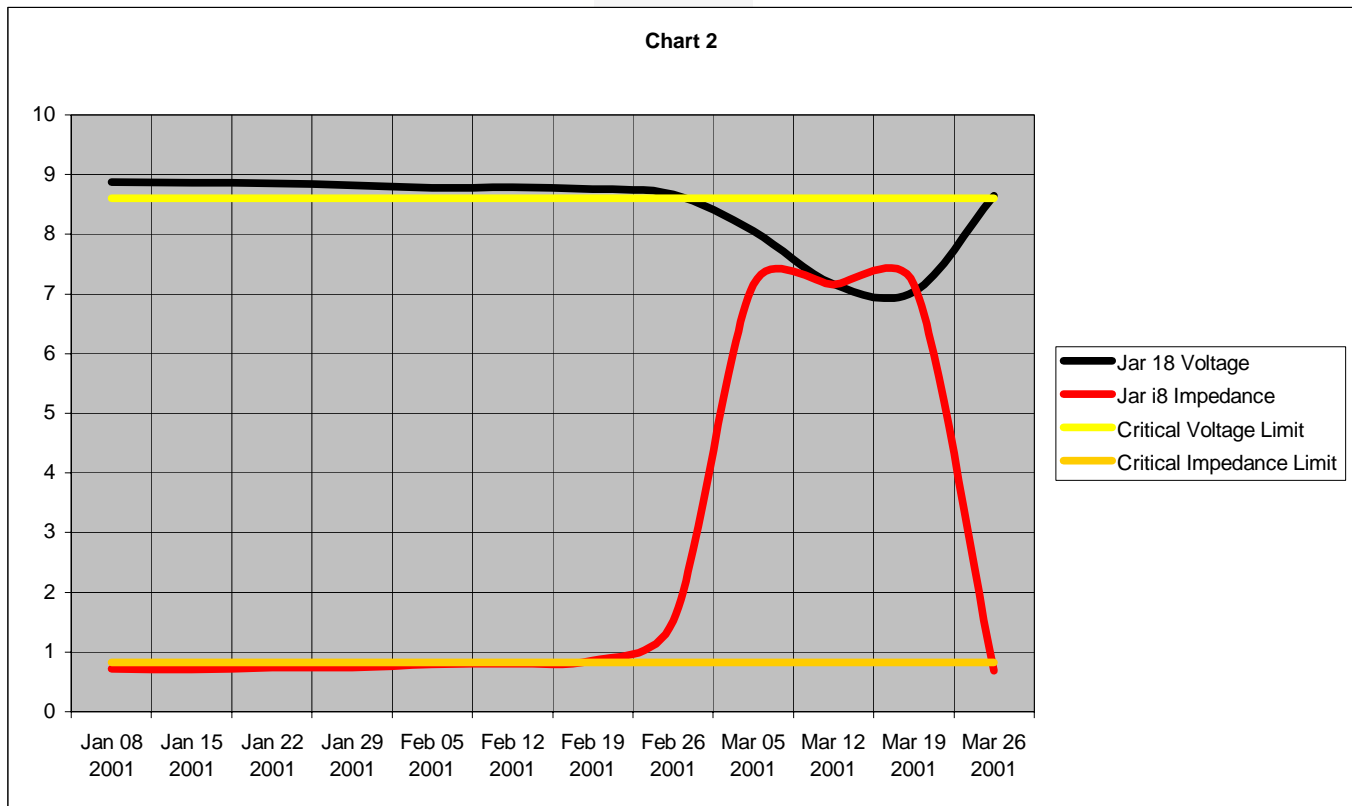
Chart 2 shows a flooded battery with an initial impedance/resistance of $0.69\text{m}\Omega$. The maintenance threshold on this battery would be $0.79\text{m}\Omega$ and the replacement threshold would be $0.83\text{m}\Omega$. This battery was installed in July 2000 replacing the battery in **Chart 1** and trended normally until late February 2001. This case could be considered infant mortality as the battery failed in only 7 months.

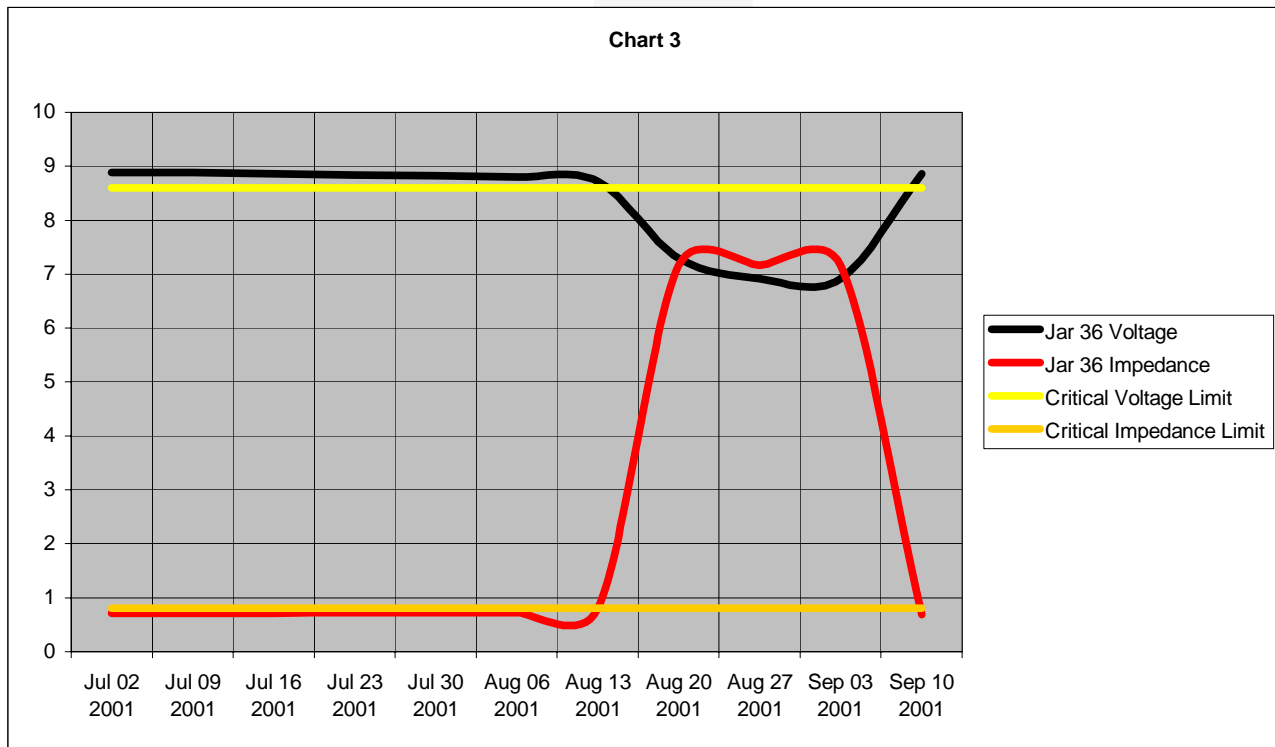
Chart 3 shows a flooded battery with an initial impedance/resistance of 0.69mΩ. The maintenance threshold on this battery would be 0.79mΩ and the replacement threshold would be 0.83mΩ. This battery was installed in December 1998 and trended normally until late August 2001.

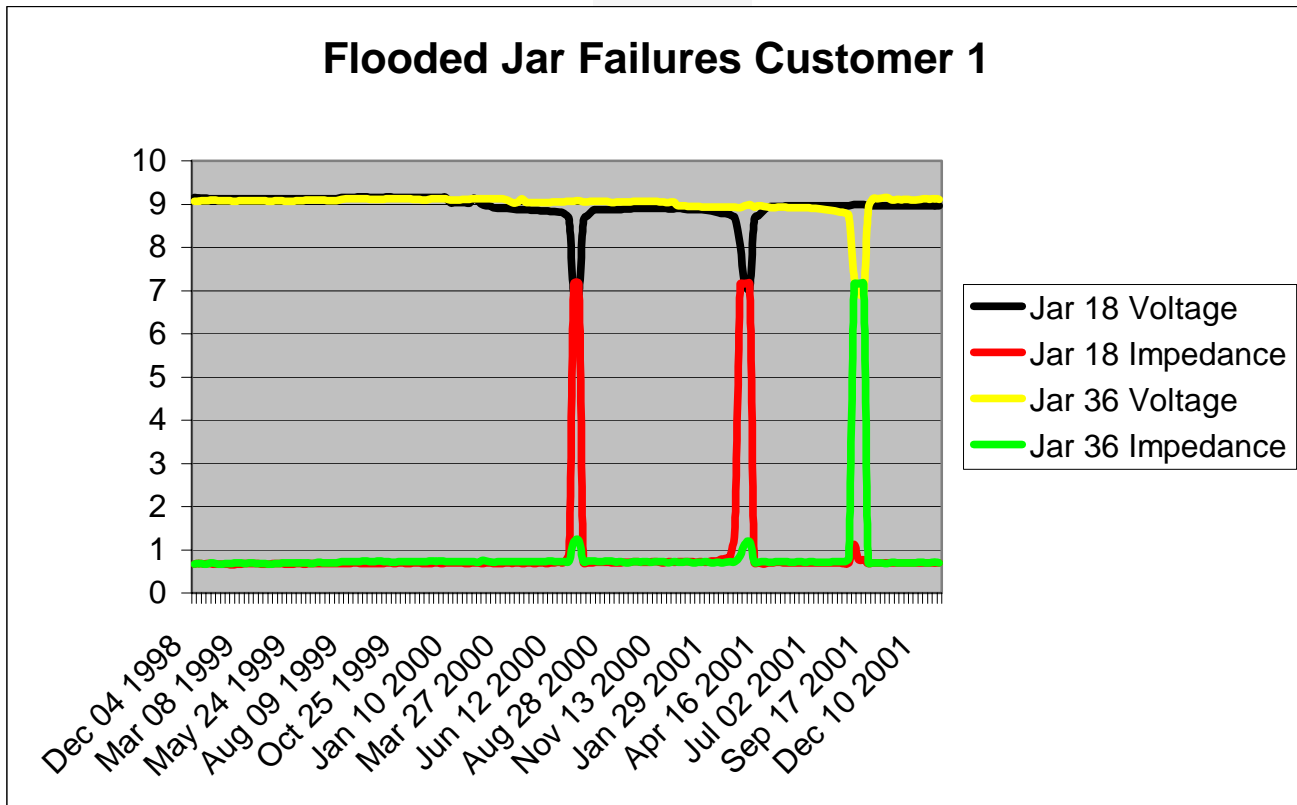
Flooded Jar Failures Customer 1

Charts 1-3 are all from the same string of batteries installed at a well designed and well operated Tier III datacenter of a major financial institution. This string and the redundant system at this site have been less eventful as the strings matured.

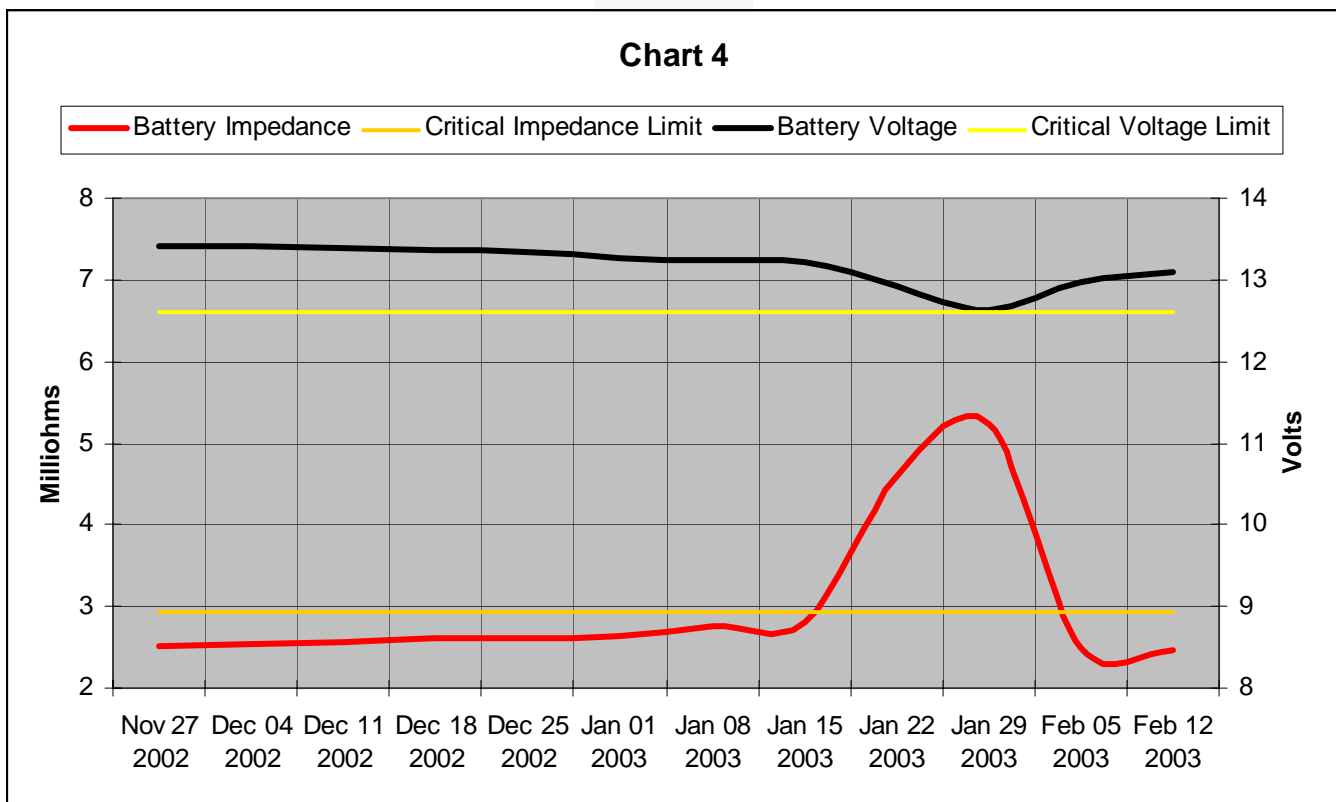
Chart 4 shows a VRLA battery with an initial impedance/resistance of 2.5mΩ. The maintenance threshold on this battery would be 3.0mΩ and the replacement threshold would be 3.125mΩ. This battery was installed in August 2000 and trended normally until late November 2002. The **Voltage Trend** demonstrates a corresponding fall in voltage sometimes associated with the rise in impedance/resistance. Also note that the replacement battery was not fully charged at the time of installation. This new battery was installed in an undercharged condition and took 8 weeks to equalize with the string.

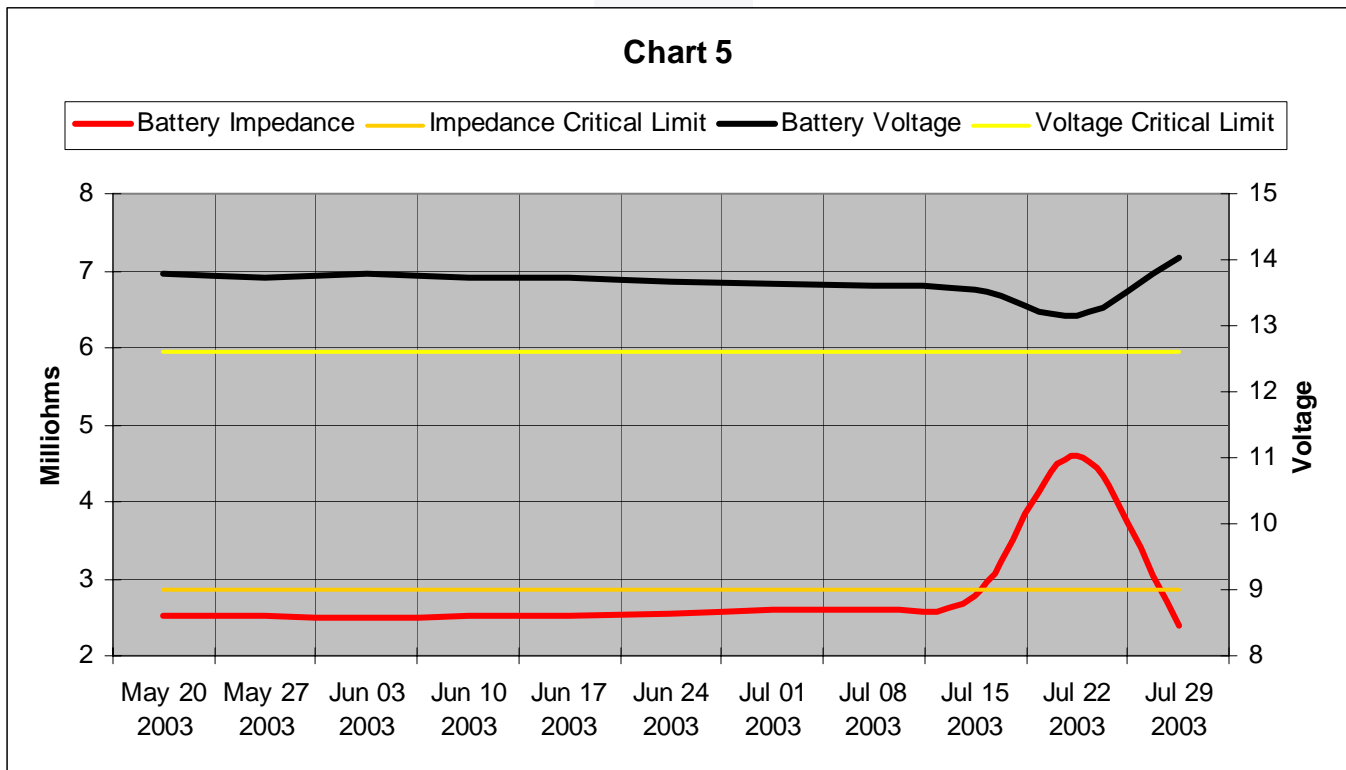
Chart 5 shows a VRLA battery with an initial impedance/resistance of 2.4mΩ. The maintenance threshold on this battery would be 2.88mΩ and the replacement threshold would be 3.0mΩ. This battery was installed in February 2001 and trended normally until late July 2003. **SIRR** in this case occurred in just 2 weeks and the battery was replaced immediately. The **Voltage Trend** again demonstrates a corresponding fall in voltage sometimes associated with the rise in impedance/resistance but remains within limits. Voltage is the lagging indicator in up to 30% of battery failures. In this case the new battery was overcharged at the time of installation and remained above 2.27 volts per cell for 6 weeks. Float voltages exceeding 2.27 volts per cell will reduce battery life.
